# DIMAX Ductile Iron Pipe Systems

## Repair Manual

This document is designed to provide a simple guide to cutting and subsequent repair of ductile iron pipe. Also repair of minor damage caused through transport & handling. This manual does not deal with all aspects of repair and assumes a general level of knowledge of ductile iron piping systems of the reader. The document should not be the only source of information. Further information can be found in other Reece documentation or by referring to qualified engineers.

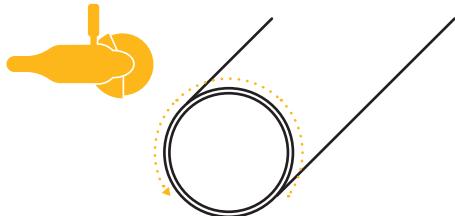
#### Chamfer dimensions:

#### Chamfer edge

- After cutting, the pipe needs to be rechamfered. It is important to reinstate the chamfer to allow for jointing of the pipes without damaging the gasket.

- When chamfering with a grinder, a sharp edge will result at the end of the chamfer. It is important to round off this sharp edge in order to avoid damage to the rubber sealing ring during joint assembly.
